**ANALYSIS OF THE CONDITION OF ECHO
TOWER AZORES FIXED ACOUSTIC RANGE,
AFTER ONE YEAR AT 1500 FEET OF DEPTH**

Naval Underwater Systems Center

Technical Note N-1284

Naval Civil Engineering Laboratory
Port Hueneme, California 93043

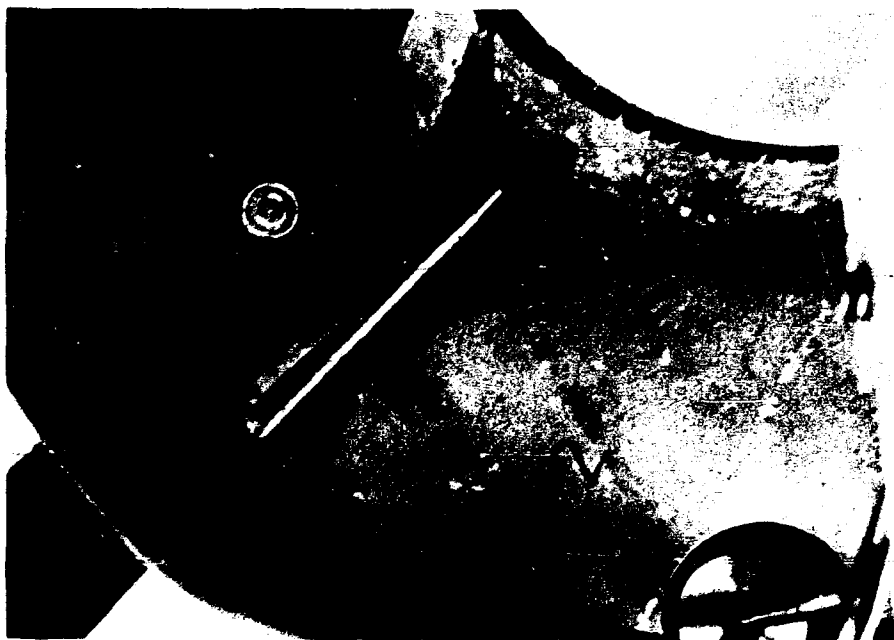
The gas generator support structure, as shown in Figure 9, had loose flaky red rust at the edges of the metal frame members. Only superficial corrosion was found associated with this rusting. The titanium cathode on the electrolytic generator, as shown in Figure 10, was unattacked. The platinum anode was also unattacked. The remaining fouling on the platinum anode was easily removed by fresh water rinsing.

Figure 10. Electrolytic gas generator cathode.

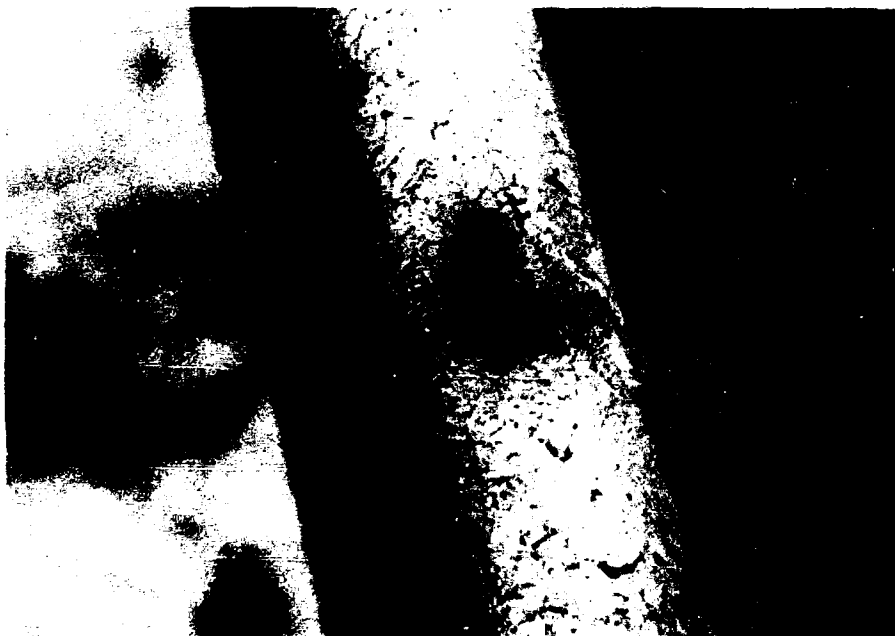
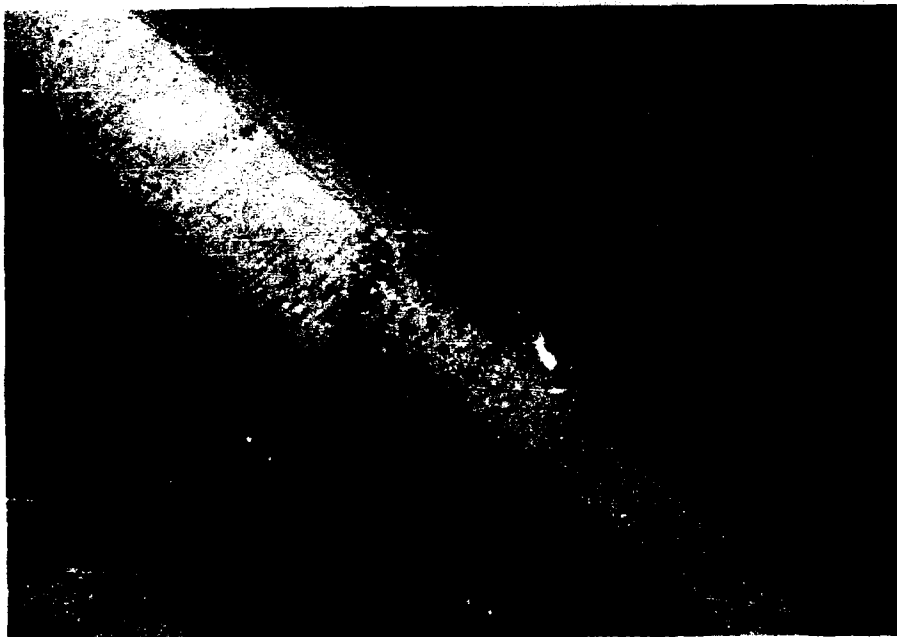
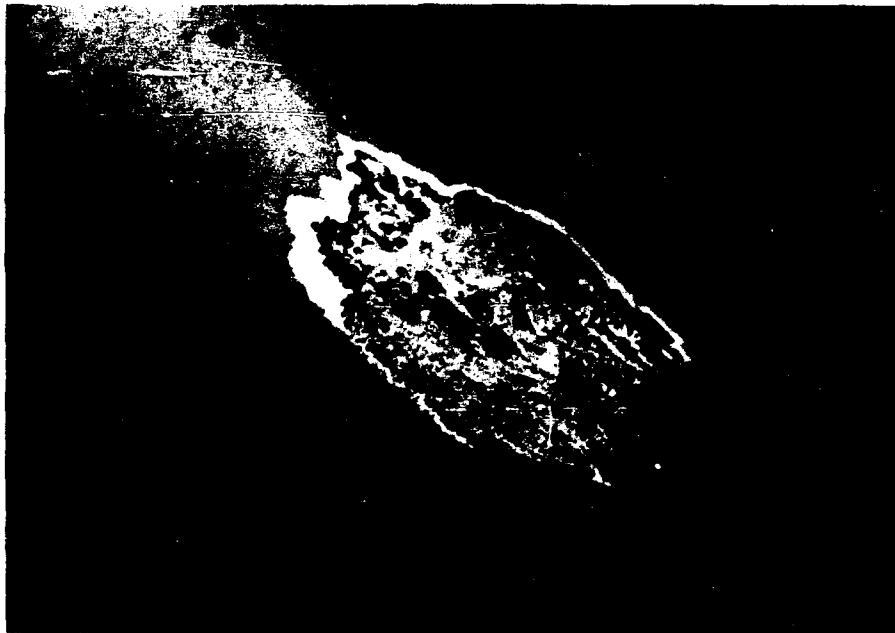
Figures 11 through 14 show the results of inspection of a typical rusted area on the middle frequency antenna. Figure 11 shows the area covered with a loose flaky red rust deposit. Figure 12 shows the area after removal of the deposit. Figure 13 shows the defects in the coating which resulted in the attack. Figure 14 shows the area after removing the coating. Note the feathered edge of the coating in Figure 14. Only three coats of paint are present. A red primer, white second coat and gray topcoat. No zinc rich primer was used on this or any other rusted areas of the compliant tubes. Brushmarks in the coatings at the rusted areas indicated that the coatings had been "touched up" at these locations without using the zinc rich primer. Removal of the upper coats of paint in an unattacked area of the low frequency antenna showed that the zinc rich primer was present.

Another area of potential failure was the attack noted on the antennas. Pits on the 1/16" thick material of high frequency compliant tubes had progressed to near penetration in a few areas. Such penetration would cause the loss of gas which would result in antenna failure. All the pits noted in the antennas were at areas of paint repair where no zinc rich primer was applied. These pits were considered to be the most severe attack noted on the tower in terms of system reliability. All other attack noted was insignificant in terms of system reliability when compared with the pits on the antennas.

Figure 11. Rusted area of middle frequency antenna.

Figure 12. Area shown in Figure 11 with rust removed.

Figure 13. Same area as in Figure 11 with rust staining removed.

Figure 14. Same area as in Figure 11 with coating removed.

The additional lifetime of the tower when reemplaced depends almost entirely on the attack on the antennas. If the pits already present reinitiate and penetrate still further the useful additional life of the tower may be as little as one year. However, if the recoating of these areas is successful and corrosion occurs at other areas the additional useful lifetime of the tower will depend on the thickness of the material on the antenna attacked. The 1/16" thick material of the high frequency antenna could last as long as five years and the others proportionately longer.

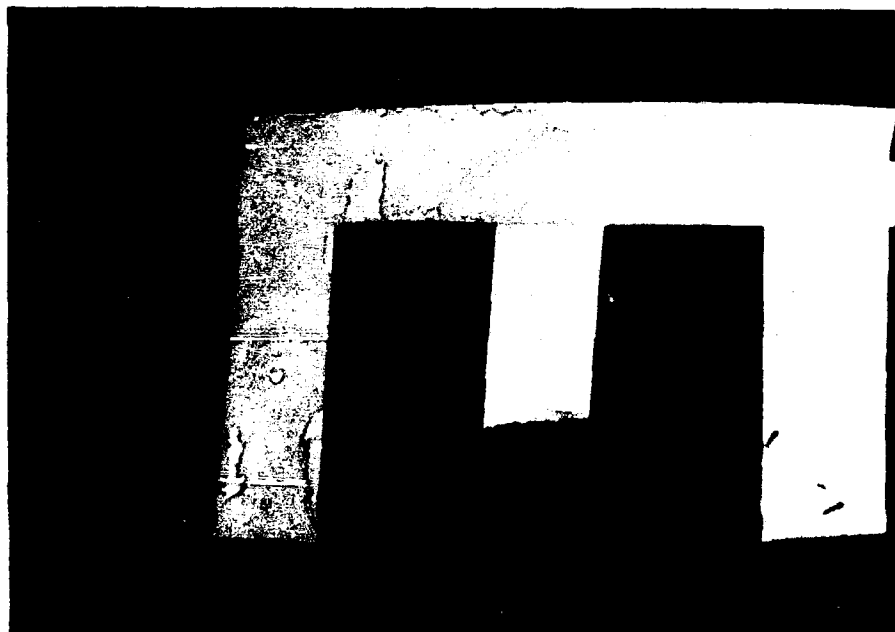
The condition of the syntactic foam blocks of the foam tower is illustrated in Figure 15. Although the coating at the identifying letter had failed, the underlying material was unattacked. No signs of water absorption or deformation of the foam blocks of the foam tower, low frequency antenna or gas generator support was noted. The main lifting eye at the top of the foam tower, as shown in Figure 16, was covered with a thin film of loose flaky red rust but no significant corrosion was noted underneath the rust layer.

Figure 15. Portion of foam tower.
